HYUNDAI Technical Service Bulletin

Group	FUEL SYSTEM	
		Number	10-FL-009	
Subject	2.0L/2.4L THETA ENGINE ETC THROTTLE BODY CLEANING		Date	JULY, 2010
			Model	NF SONATA, YF SONATA, CM SANTA FE, LM TUCSON, BK GENESIS COUPE
CIRCULATE TO:	<input type="checkbox"/> GENERAL MANAGER	<input checked="" type="checkbox"/> PARTS MANAGER	<input checked="" type="checkbox"/> TECHNICIAN	
<input checked="" type="checkbox"/> SERVICE ADVISOR	<input checked="" type="checkbox"/> SERVICE MANAGER	<input checked="" type="checkbox"/> WARRANTY MGR	<input type="checkbox"/> SALES MANAGER

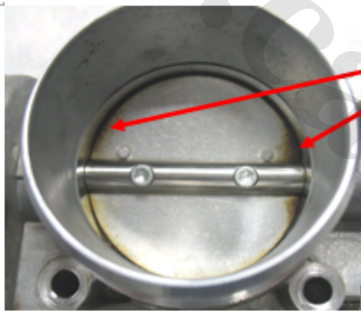
Deposits
found at the
valve to bore
interface.

Any of the following conditions may be caused by throttle body deposits:

- No start (due to throttle valve stuck closed or air flow significantly restricted)
- Rough idle or fluctuating engine speed at idle (due to air flow restricted)
- MIL "On" with DTC P2118 or P2119 occurring along with P2110:
 - P2118: Throttle Actuator Control Motor Current Range/Performance
 - P2119: Throttle Actuator Control Throttle Body Range/Performance
 - P2110: Throttle Actuator Control System-Forced Limited Power

4. Spray a carbon cleaner or throttle body cleaning solution on the throttle valve and bore areas where deposits have accumulated. Wipe off the deposits with a clean and soft shop towel (as shown in the pictures).
