by Larry Frash

Familiar Failures and Faithful Fixes for the Mazda FN4A-EL and Ford 4F27E

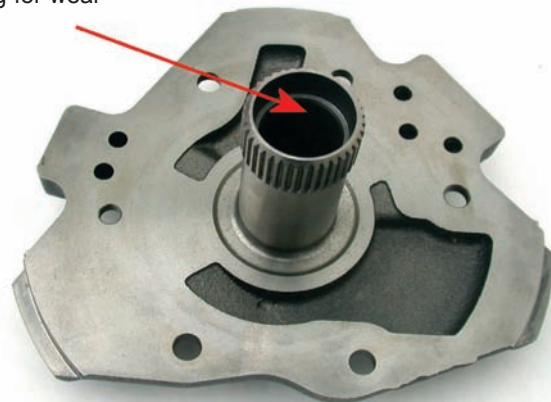
Figure 1

The stator support bushings support the turbine shaft (figures 1 and 2), but they also separate the TCC apply and release pressures. With lockup released, converter charge pressure is delivered between the converter clutch and the apply surface (the front converter cover). This hydraulic pressure is called *converter release pressure*, and that pressure is what keeps the converter clutch from applying.

When the stator support bushings are worn, they can allow converter apply pressure to leak into the release side of the converter. When this occurs,

Always check this bushing for wear

Worn stator support bushings allow converter apply pressure to cross leak into the release circuit causing lockup slippage

converter release pressure can't exhaust fast enough, so it keeps pressure on the release side of the converter clutch. This prevents the converter clutch from fully applying, which causes the converter clutch to slip.

To avoid this problem, always check for wear between the stator support bushings and turbine shaft, whenever you're rebuilding one of these transmissions. If you find more than 0.0015" clearance, replace the bushings. These bushings are made by Omega Machine & Tool, Inc. and are available from a number of sources in the aftermarket.

Once you've replaced the bushings, slide the stator shaft into place and recheck the clearance between the shaft and the bushings; while not particularly common, it is possible for the shaft itself to wear and need replacement.

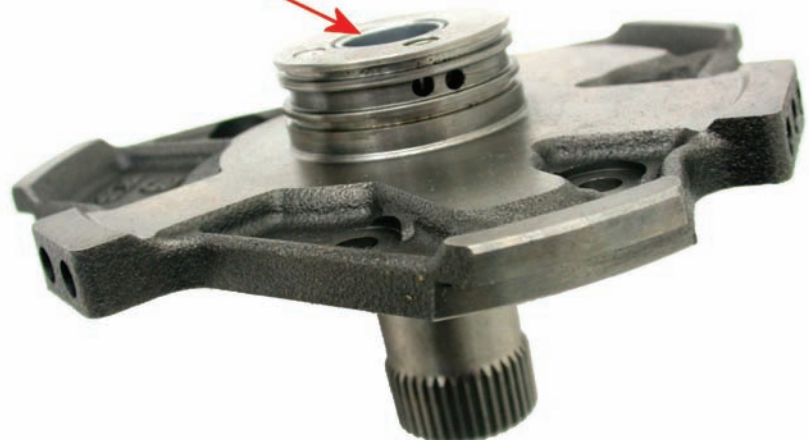
Figure 2

Always check this bushing for wear

Worn stator support bushings allow converter apply pressure to cross leak into the release circuit causing lockup slippage

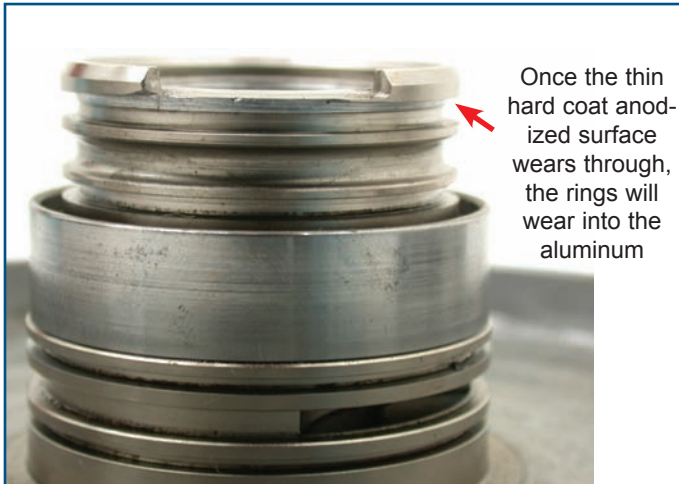
Figure 3

It's not uncommon to see wear in the end cover, around the top direct

clutch ring land area (figure 3). On Mazda applications, the end cover is aluminum and is hard coat anodized around the ring land area (figure 4). This hard coating is designed to prevent the rings from wearing into the soft aluminum. Once the thin anodized coating wears through, the ring wears into the bare aluminum, destroying the cover.

So, to avoid wear in the end cover, you should always use the Ford cover. Whenever you rebuild an FN4A-

EL/4F27E transmission, check the end cover carefully to see which one is being used. Never reuse the hard coat anodized cover, even if there's no sign of wear in the ring area. Always replace the Mazda-style end cover with a Ford cover, part# XS4Z-7222-BA. This cover will work on all models, with a few minor modifications:

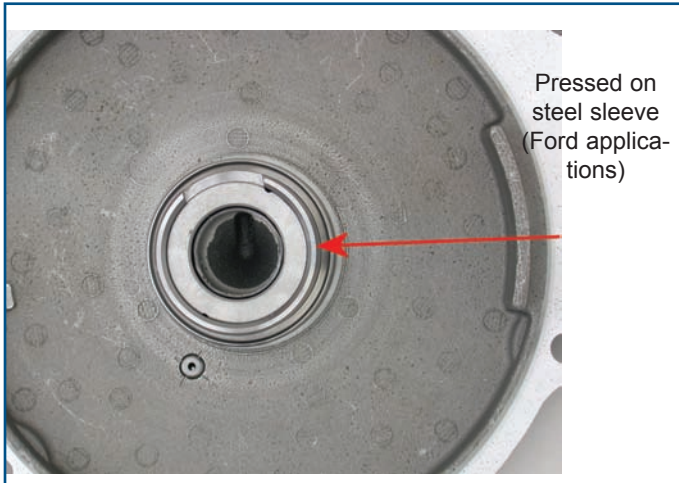
Figure 5

The end cover used in Ford applications is also made out of aluminum, but this cover has a pressed steel sleeve for the ring land area (figure 5). And, since the direct clutch rings ride against the steel surface, ring land wear isn't a problem on Fords.

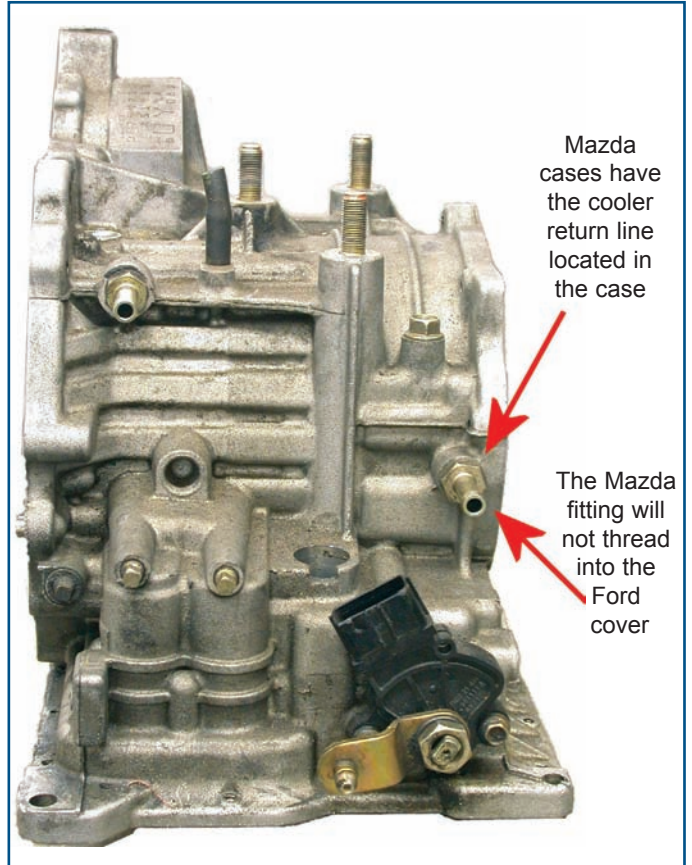
Figure 6

The Mazda version of the FN4A-EL/4F27E transmission has the cooler return line located in the case (figure 6). From there it's routed through a passage to the end cover to provide

To adapt the Ford cover for use with a Mazda transmission, you must reroute the cooler return circuit.

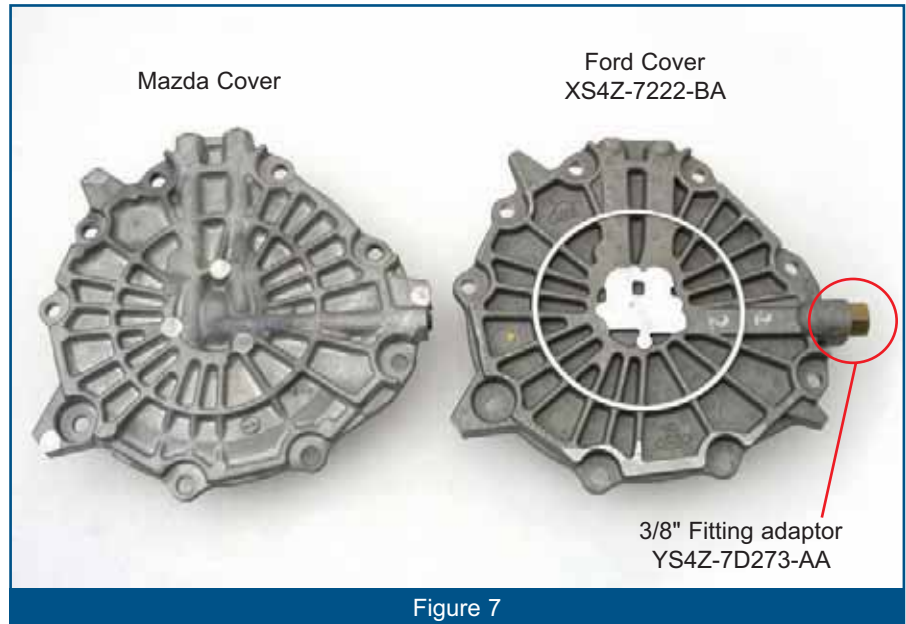
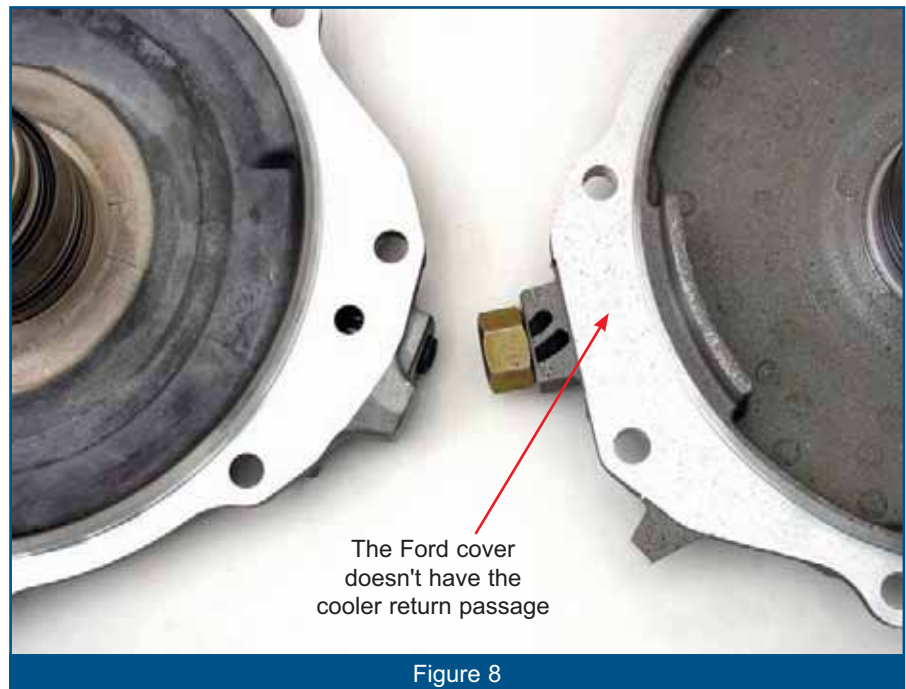
lube oil to the transmission. The Ford version of this transmission has the cooler return line threaded directly into the end cover. Because of this, the Ford end cover doesn't have the cooler return passage from the case that the Mazda cover has (figure 7 and 8).

To adapt the Ford cover for use with a Mazda transmission, you must reroute the cooler return circuit. Here's how:

Remove the original cooler line fitting from the Mazda case to use it as a template to make a new fitting. The threads are different and won't fit the Ford end cover. When you order the Ford end cover, also order a 3/8" fitting adaptor from Ford, part# YS4Z-7D273-AA. Install it into the Ford end cover.

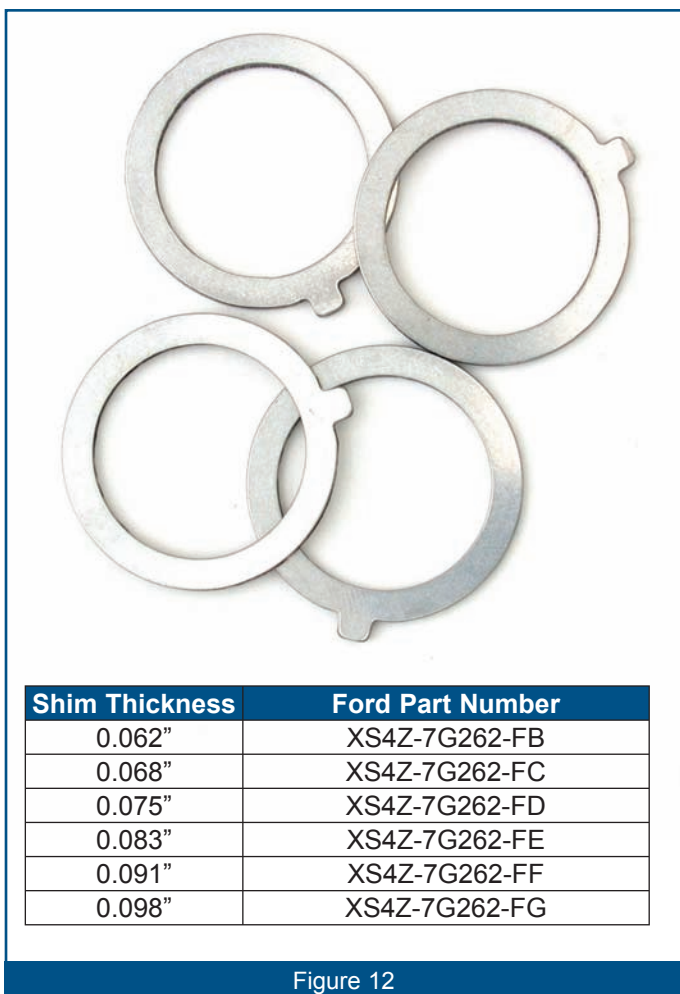
Figure 12

endplay for this transmission is 0.010" to 0.019". Corrective shims for adjusting endplay are available from Ford, and range from 0.062" to 0.098" (figure 12).

Any time you change hard parts in a transmission, always check the endplay. Proper

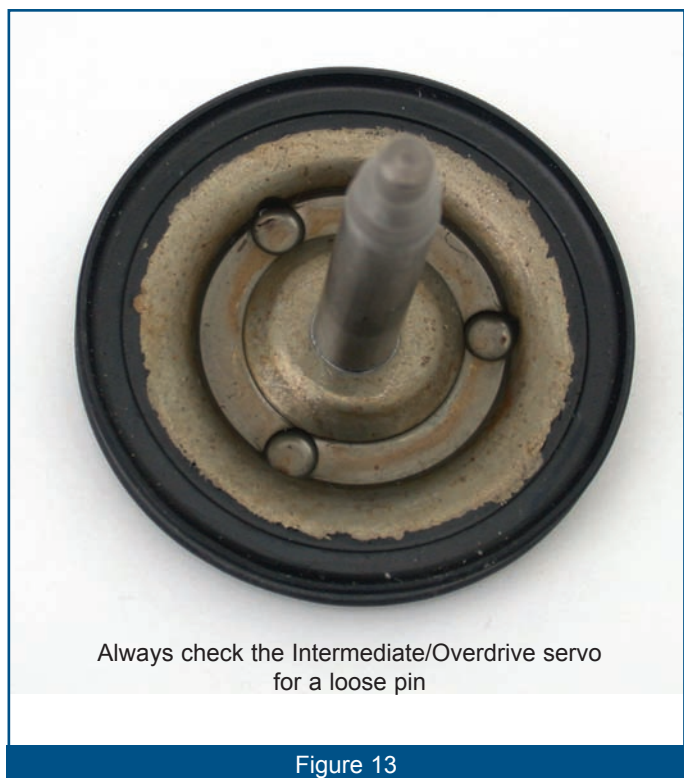
Figure 13

The intermediate/overdrive band servo is a molded rubber piston with a pressed-in pin (figure 13). Problems occur when the pin becomes loose in the piston and causes leaks between the apply side and the release side of the servo. Symptoms of a loose pin can include:

- Ratio errors
- 2nd gear slip
- 2-3 flare
- 3rd gear slip

But the most common symptoms caused by a loose servo pin are a slip in 4th gear and 4th gear ratio codes. If the pin gets loose enough, it will come completely out of the piston, causing major problems (figure 14). To avoid problems from this servo, always replace the servo with a new one during every rebuild.

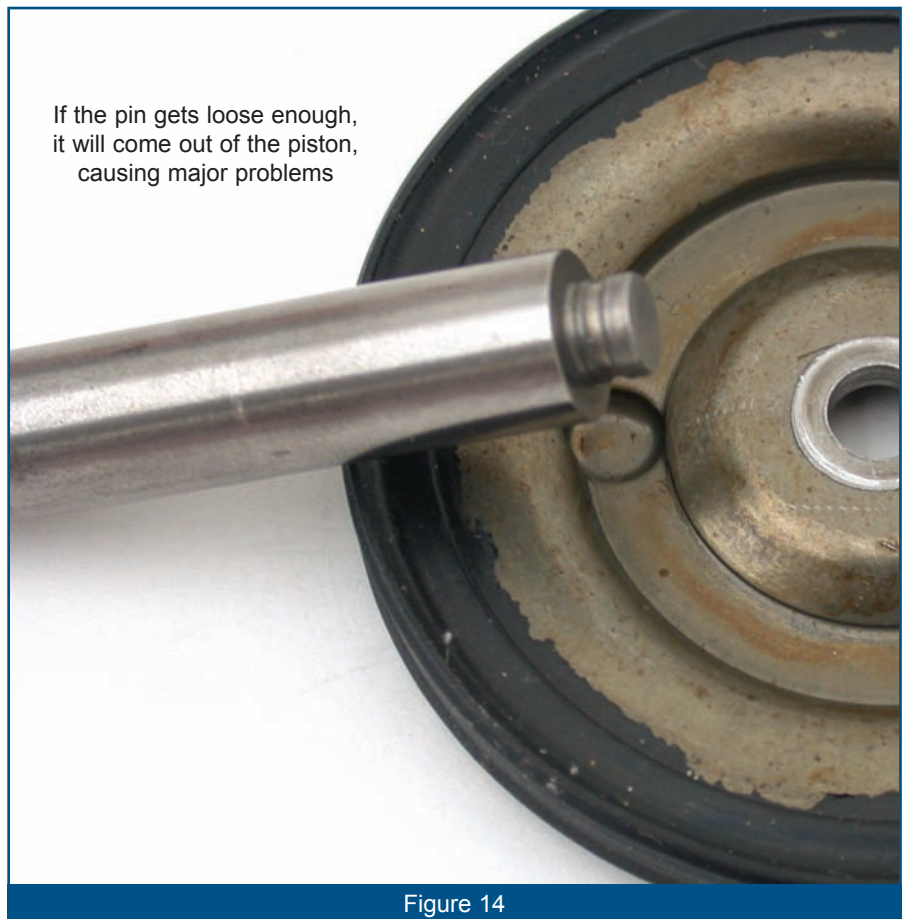
Figure 14

But the most common symptoms caused by a loose servo pin are a slip in 4th gear and 4th gear ratio codes.
